**Flood Control Project Maintenance
Levee Inspections**

Maintenance Issue Types Only, Levee Inspection Report By Mile - Fall 2018

Merced Streams Group

Waterway	Bank	Unit Miles	Inspection Start/End	Inspector
Unit No. 01 Black Rascal Diversion	Right	1.61	10/23/2018 10/23/2018	Corey Fujitani

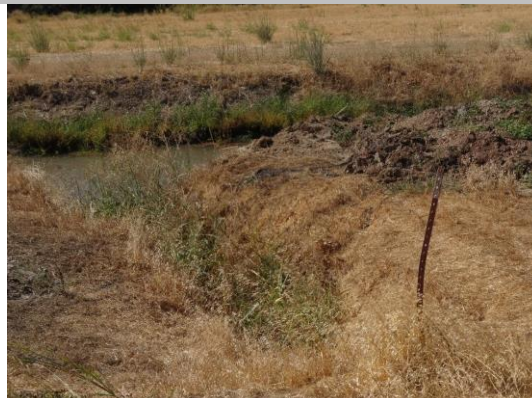
Photo 1 of 3 : UCIP_FA_2018_20946_35266.jpg

LM Start	0.54	Rating **	M	Issue No.	27	
LM End	0.54	Issue Type +	Ma	Location *		
Category	Supplemental			GPS Latitude/Longitude		
				Start		End
Item	DWR UCIP LMA Responsibility			37.333180 °		37.333180 °
				-120.394069 °		-120.394069 °
DWR ID	23054					
Comment Code						
Inspector Comment						
FS_ID:20946 DS_ID:23054 EP_NO: N/A Repair Type: Non-Urgent Crossing Status: Found UCIP Comments: 09/17/2013 - needs vegetation cleaning on both sides.- flap gate was not properly closed during field survey.- inlet needs cleaning. (DWR UCIP - P. Amatya) FIELD_STRUCT_DESC: 24-inch corrugated metal gravity drainage pipe through the levee, 12 feet below the crown. Concrete headwall, flap gate, and concrete grouted cobble spillway on the waterside (WS) toe. Concrete headwall on the landside (LS) toe. [Additional Reference(s): DWR Levee Log, 2005]. FS Date: 9/17/2013

WS view: cobble spillway and channel on waterside.

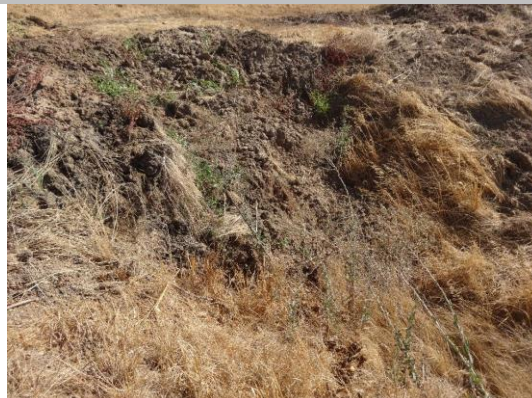
Photo 2 of 3 : UCIP_FA_2018_20992_35369.jpg

Comment Code						
Inspector Comment						
FS_ID:20992 DS_ID:23055 EP_NO: N/A Repair Type: Non-Urgent Crossing Status: Found UCIP Comments: 09/17/2013 - mud and debris from recent channel cleaning needs to be removed from spillway and outlet - pipe filled with debris, it needs cleaning.- half of intet pipe burried. (DWR UCIP - P. Amatya) FIELD_STRUCT_DESC: 24-inch corrugated metal gravity drainage pipe through the levee, 8 feet below the crown. Concrete headwall, flap gate, and concrete grouted cobble spillway on the waterside (WS) toe. Concrete headwall on the landside (LS) toe. [Additional Reference(s): DWR Levee Log, 2005. USACE San Joaquin O&M Manual 607, June 1962, (HLM 0.73)]. FS Date: 9/17/2013

WS view: debris and mud deposited from the channel cleaning. It needs to be cleared from spillway and outlet structure.

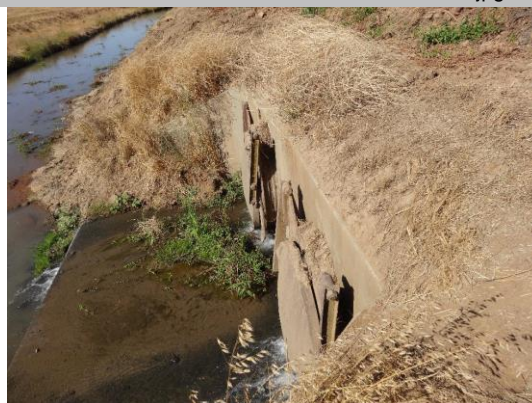
Photo 1 of 3 : UCIP_FA_2018_20965_35292.jpg

Comment Code					
Inspector Comment					
FS_ID:20965					
DS_ID:23056					
EP_NO: N/A					
Repair Type: No Action Needed					
Crossing Status: Found					
UCIP Comments: 09/17/2013 - working during field inspection. -					
vegetation on drainage ditch/channel (DWR UCIP - P. Amatya)					
FIELD_STRUCT_DESC: 1 of 2: 60-inch corrugated metal gravity					
drainage pipe through the levee, 10 feet below the crown. Concrete					
headwall and flap gate on the waterside (WS) berm, 5 feet from the					
levee toe. Concrete headwall on the landside (LS) toe. [Additional					
Reference(s): DWR Levee Log, 2005. USACE San Joaquin O&M					
Manual 607, June 1962, (HLM 0.91)].					
FS Date: 9/17/2013

WS view: two 60" CMPs, flap gates, and headwall on channel bank.

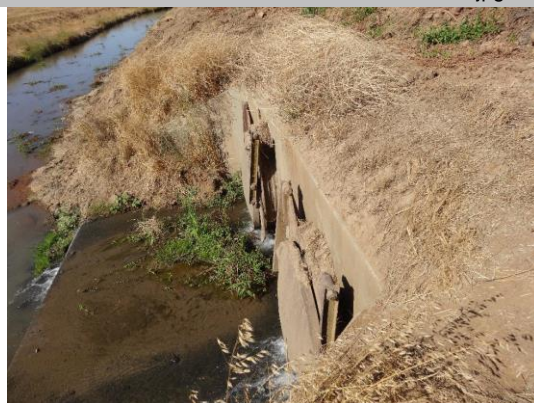
Photo 1 of 3 : UCIP_FA_2018_20983_35302.jpg

LM Start	0.91	Rating **	A/W	Issue No.	30	
LM End	0.91	Issue Type +	Ma	Location *		
Category	Supplemental			GPS Latitude/Longitude		
				Start		End
Item	DWR UCIP LMA Responsibility			37.328267 °		37.328267 °
				-120.396084 °		-120.396084 °
DWR ID	23080					
Comment Code						
Inspector Comment						
FS_ID:20983 DS_ID:23080 EP_NO: N/A Repair Type: No Action Needed Crossing Status: Found UCIP Comments: 09/17/2013 It was working during field inspection. Dense vegetation in drainage ditch (DWR UCIP - P. Amatya). FIELD_STRUCT_DESC: 2 of 2: 60-inch corrugated metal gravity drainage pipe through the levee, 10 feet below the crown. Concrete headwall and flap gate on the waterside (WS) berm, 5 feet from the levee toe. Concrete headwall on the landside (LS) toe. [Additional Reference(s): DWR Levee Log, 2005. USACE San Joaquin O&M Manual 607, June 1962, (HLM 0.91)]. FS Date: 9/17/2013

WS view: two CMPs with flap gate, concrete spillway and channel on waterside.

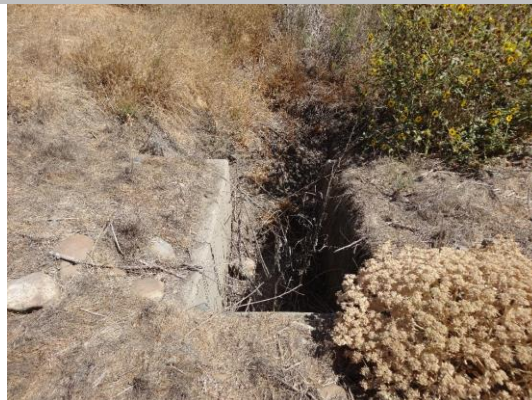
Photo 1 of 3 : UCIP_FA_2018_50144_35422.jpg

WS view: U typed concrete headwall, cobble spillway, and channel on waterside.

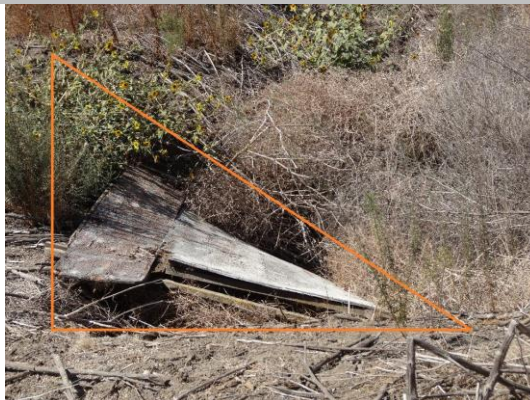
Photo 3 of 3 : UCIP_FA_2018_50144_35420.jpg

LS view: Debris dumped on inlet structure. Needs to be cleared or abandoned properly.

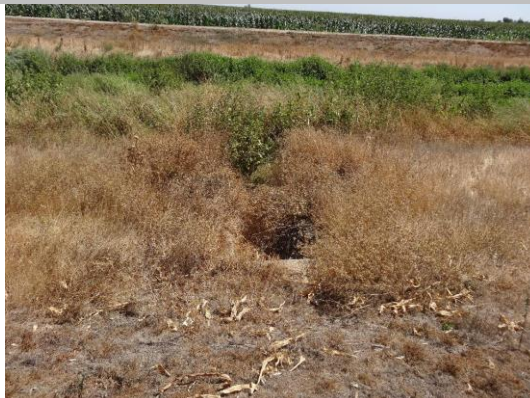
Photo 1 of 3 : UCIP_FA_2018_50151_35539.jpg

WS view: overview of spillway/outlet area on waterside.

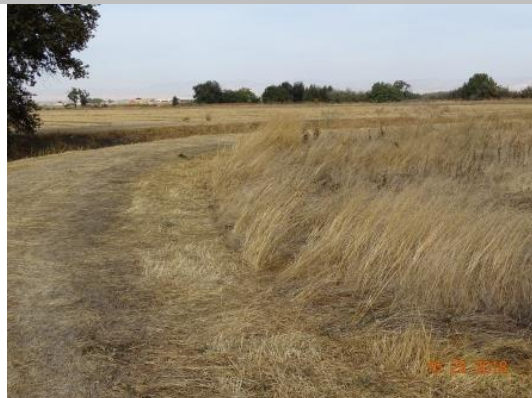
Photo 1 of 1 : FA_2018_NA0013_334_15_20181108_00031.jpg

LM Start	0.00	Rating **	U	Issue No.	15
LM End	0.15	Issue Type +	Ma	Location *	LS
Category	Earthen Levee			GPS Latitude/Longitude	
				Start	End
Item	Vegetation				° 37.272847 °
					° -120.280015 °
DWR ID	DWR_NA0013_04_f_2018_15				
Comment Code					
V1 : Control annual grass and weeds on the levee slopes and easements.					
Inspector Comment

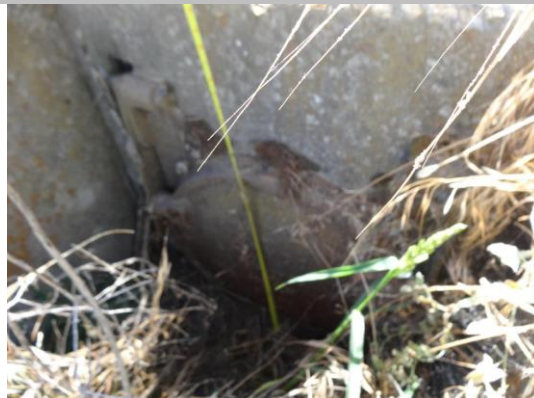
Photo 2 of 3 : UCIP_FA_2018_42991_35750.jpg

Comment Code						
Inspector Comment						
FS_ID:42991						
DS_ID:23068						
EP_NO: N/A						
Repair Type: Non-Urgent						
Crossing Status: Found						
UCIP Comments: 09/17/2013 - needs vegetation clearing on both sides. Flapgate blocked by debris on WS. - inlet and outlet need silt clearing and cleaning. (DWR UCIP - P. Amatya)						
FIELD_STRUCT_DESC: 24-inch corrugated metal gravity drainage pipe through the levee, 5 feet below the crown. Concrete headwall, flap gate, and concrete grouted cobble spillway on the waterside (WS) toe.						
Concrete headwall on the landside (LS) toe. [Additional Reference(s): DWR Levee Log, 2005. USACE San Joaquin O&M Manual 607, June 1962, (HLM 0.10)].						
FS Date: 9/17/2013

WS view: U typed concrete headwall, CM pipe, and flap gate. Vegetation and silt need to be cleared.

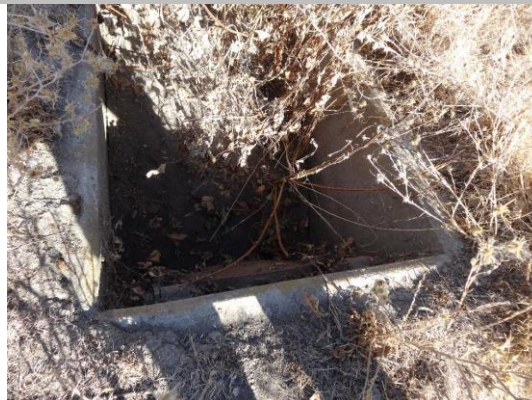
Photo 1 of 3 : UCIP_FA_2018_50146_35748.jpg

WS view: U typed concrete headwall, CM pipe, and flap gate. Vegetation needs to be cleared.

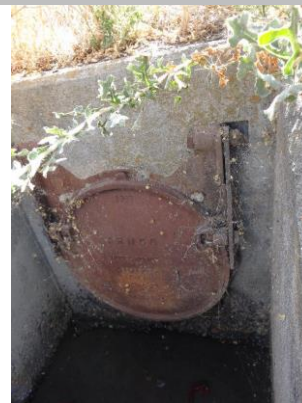
Photo 2 of 3 : UCIP_FA_2018_50148_35612.jpg

WS view: U typed concrete headwall, CM pipe, and flap gate.

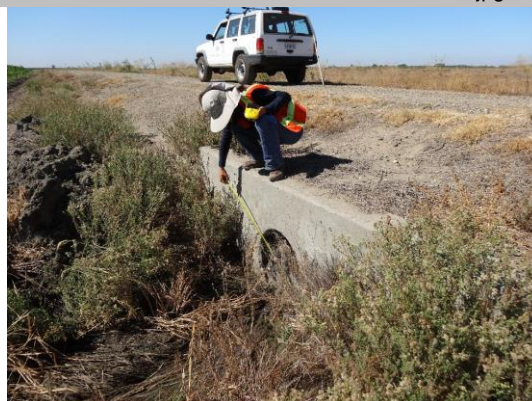
Photo 3 of 3 : UCIP_FA_2018_50148_35611.jpg

Comment Code						
Inspector Comment						
FS_ID:50148 DS_ID:23071 EP_NO: N/A Repair Type: No Action Needed Crossing Status: Found UCIP Comments: 09/29/2016: WS headwall, flap gate and spillway have been cleared of vegetation by Mike Walejko of NA0013. Crossing has been downgraded from Non-Urgent to No Action Needed. (K. Fazel - UCIP)09/2013:- vegetations clearing on spillway area. (P. Amatya - UCIP) FIELD_STRUCT_DESC: 24-inch corrugated metal gravity drainage pipe through the levee, 5 feet below the crown. Concrete headwall, flap gate, and concrete grouted cobble spillway on the waterside (WS) toe. Concrete headwall on the landside (LS) toe. [Additional Reference(s): DWR Levee Log, 2005. USACE San Joaquin O&M Manual 607, June 1962, (HLM 0.45)]. FS Date: 9/7/2016

LS view: concrete headwall and CM pipe.

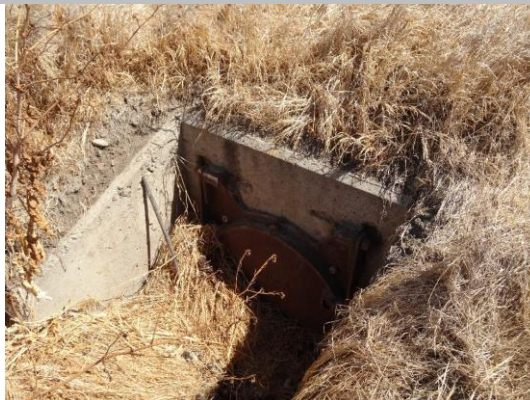
Photo 1 of 3 : UCIP_FA_2018_50153_35745.jpg

Comment Code					
Inspector Comment					
FS_ID:50153 DS_ID:23076 EP_NO: N/A Repair Type: No Action Needed Crossing Status: Found UCIP Comments: 09/01/2016: Per Mike Walejko, WS outlet has been cleared. See photos. Crossing has been downgraded from Urgent to No Action Needed. (K. Fazel - UCIP)08/23/2016: LS inlet is clear. WS outlet is still buried. Cracks on crown characteristic of entire left bank and not associated with the crossing at this location. (K. Fazel - UCIP)09/17/2013:- significant levee crown and slope cracks along the pipe. Detailed investigation required.- inlet pipe buried on landside. Needs removal of silts. Needs clearing and cleaning.- half of outlet pipe buried. Needs clearing and removal of vegetations and silts. (P. Amatya - UCIP) FIELD_STRUCT_DESC: 24-inch corrugated metal gravity drainage pipe through the levee, 10 feet below the crown. Concrete headwall, flap gate, and concrete grouted cobble spillway on the waterside (WS) toe. Concrete headwall on the landside (LS) toe. [Additional Reference(s): DWR Levee Log, 2005. USACE San Joaquin O&M Manual 607, June 1962, (HLM 1.24)]. FS Date: 9/1/2016

WS view: U typed concrete headwall, CM pipe, and flap gate. Dirt and vegetations need to be removed and cleared.
